Virginia Department of Mines, Minerals & Energy
Division of Mines

Accident Investigation Report
Underground Coal Mine

Electrocution Fatality
January 21, 2003

Dorchester Enterprises, Inc.
Mine No. 4
Mine Index No. 14698AA
Wise County, Virginia

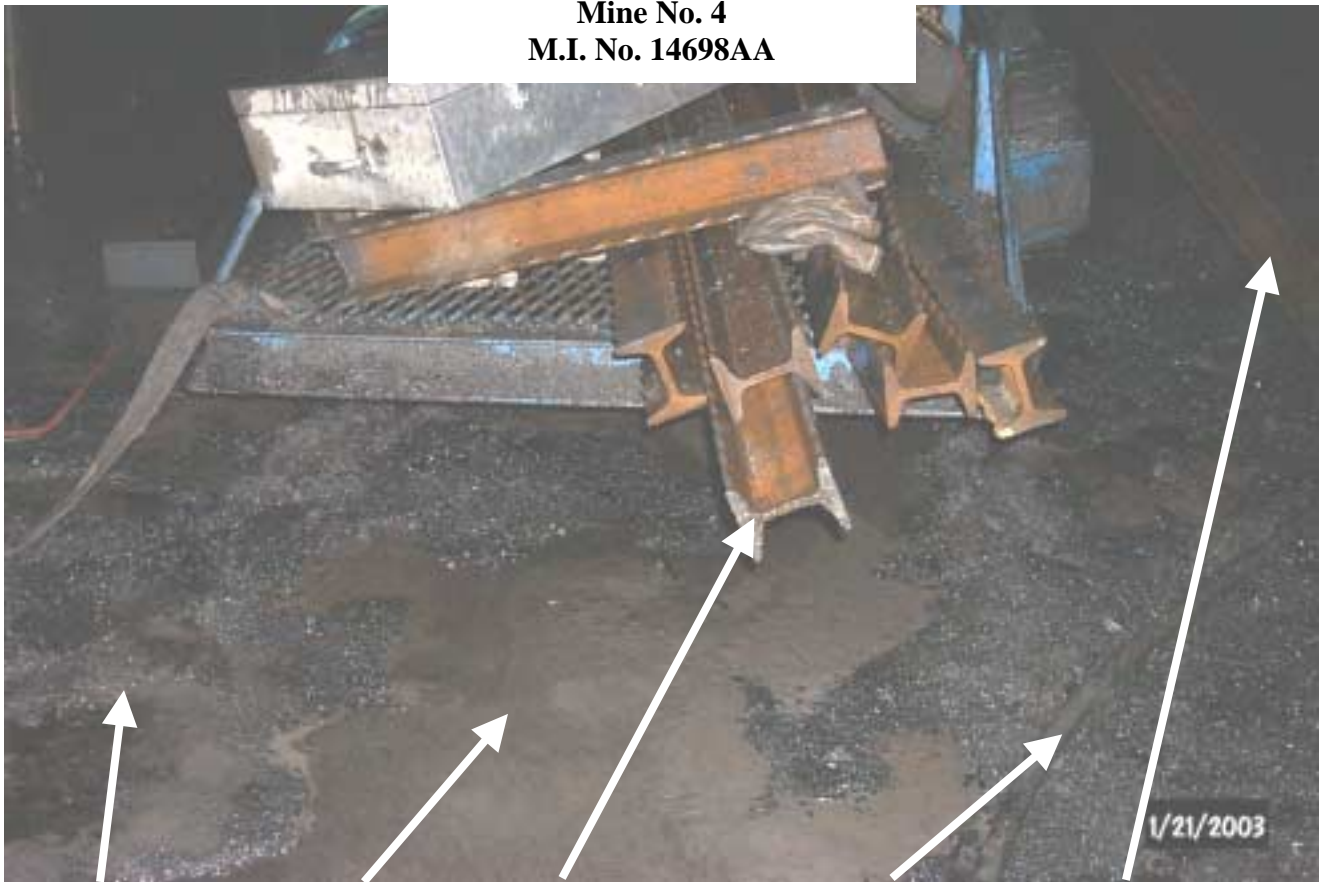
**Fatal Accident Scene
Dorchester Enterprises, Inc.
Mine No. 4
M.I. No. 14698AA**

**Coal/Water
Slurry**

**Standing
Water**

**Victim lying across
beam – head on
right side of beam**

**Roof Bolting
Machine Cable**

**Steel beam with end cut -
found lying approx. 6”
from cable**

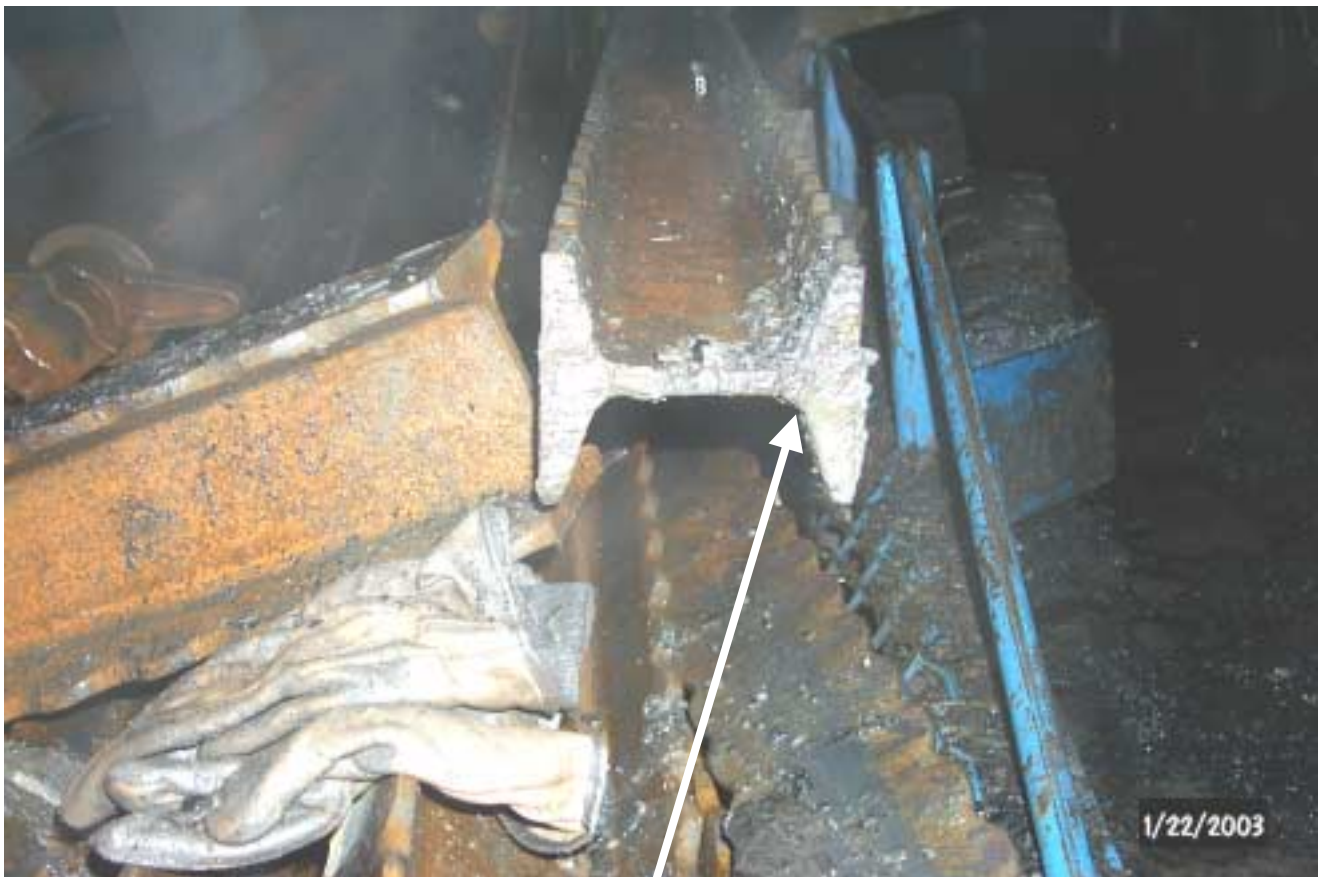
End of steel beam that had been cut with oxygen/acetylene torches – end of beam was observed lying approx. 6” from the damaged location on the roof bolting machine cable.

7. The beam that had been cut was observed lying partially on the trailer with the cut end lying against the mine floor in close proximity to but not touching the 480 volt, three phase, alternating current, No. 1 roof bolting machine trailing cable that was energized when the accident occurred. The cut end of the beam had a jagged edge with protruding slag that resulted from the cutting process. This cut end of the beam had been hot when placed on the mine floor in the immediate vicinity where the energized No. 1 roof bolting machine trailing cable was located.

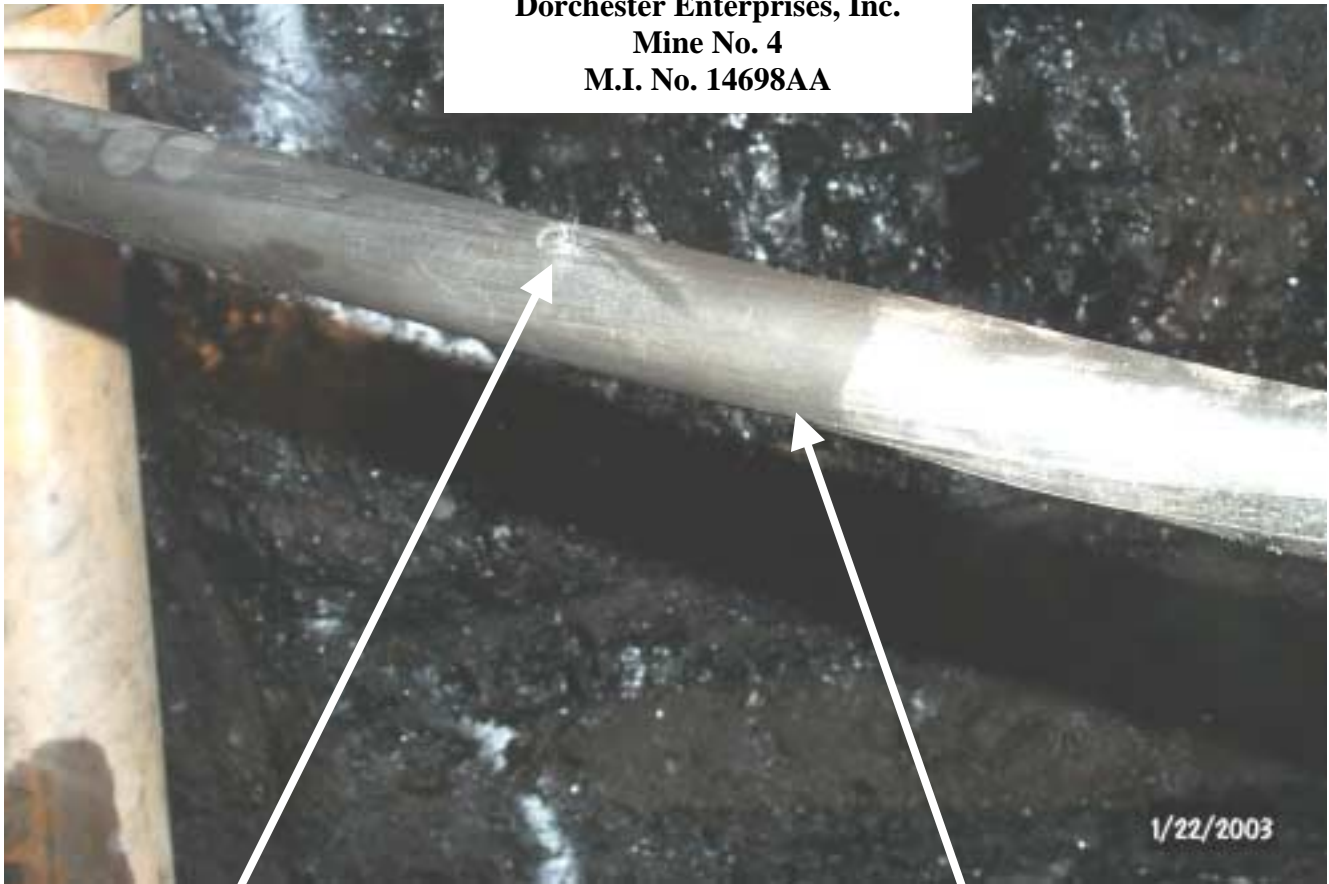
**Fatal Accident Scene
Dorchester Enterprises, Inc.
Mine No. 4
M.I. No. 14698AA**

Damaged Cable Insulation

Roof Bolting Machine Cable

10. A damaged place on the energized 480-volt, No. 1 roof bolting machine trailing cable was observed in close proximity to but not touching the end of the beam that had been cut. The outer insulation of the trailing cable had been ruptured and physical damage had exposed the red phase conductor inside the cable. The damaged place on the cable was the most likely source of electricity that could have energized the metal trailer and beams.

1. Recognize the potential hazards created when work activities are being conducted around electrical cables.
2. Trailing cables shall be protected against mechanical injury by hanging to the mine roof or by location to prevent damage from equipment or other work being performed in the affected area.
3. Miners should immediately de-energize power to any equipment or cable when stray electrical current is detected. This hazardous condition should be reported to the foreman and electrical repairman immediately.
4. Miners should wear rubber gloves when handling any type of energized low and medium voltage cables. Rubber boots provide additional protection and should be worn when practical.
5. The foreman and repairman should ensure that reports of damaged cables are checked and corrected immediately.

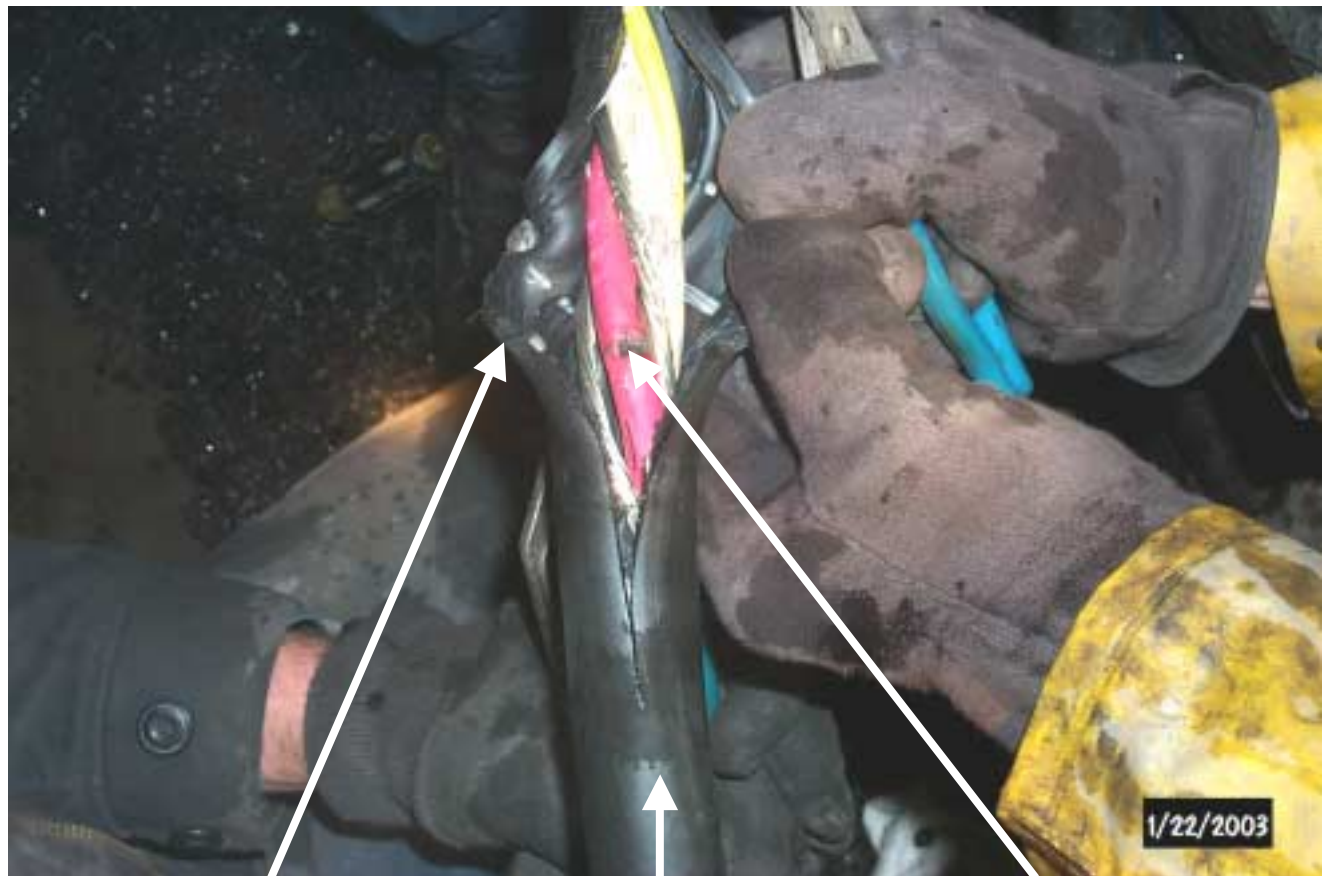
**Damaged cable insulation
area cut open for inspection**

**Roof bolting
machine cable**

**Damaged power
conductor insulation**

- A section of the trailing cable outer jacket was removed at the damaged place to evaluate the condition of the three phase power conductors. This examination revealed damage to the insulation provided for the red phase power conductor which had destroyed a small segment of insulation, exposing the phase conductor;

- A section of roof bolting machine trailing cable containing the damaged place was sent to the Federal Mine Safety and Health Administration's Approval and Certification Center located in Triadelphia, West Virginia, for testing. Mr. David Creamer, Chemist of the Materials and Explosions Testing Branch, examined and tested the section of damaged cable. Mr. Creamer concluded that the red phase power conductor insulation had been damaged by an external heat source.
